**NTSB** National Transportation Safety Board

*Office of Highway Safety*

# Fire Cause and Propagation

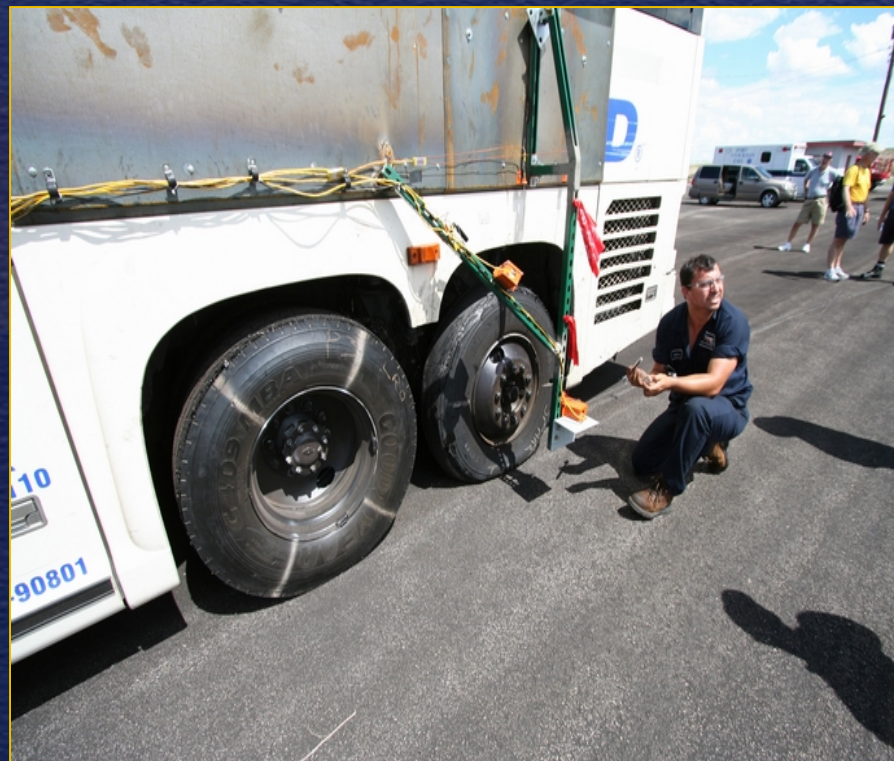
# Tire Fire Testing

Wheel bearing failure:

- Wheel component temperatures can exceed 1300° F
- Heat spreads through hub and rim
- Heat ignites tire

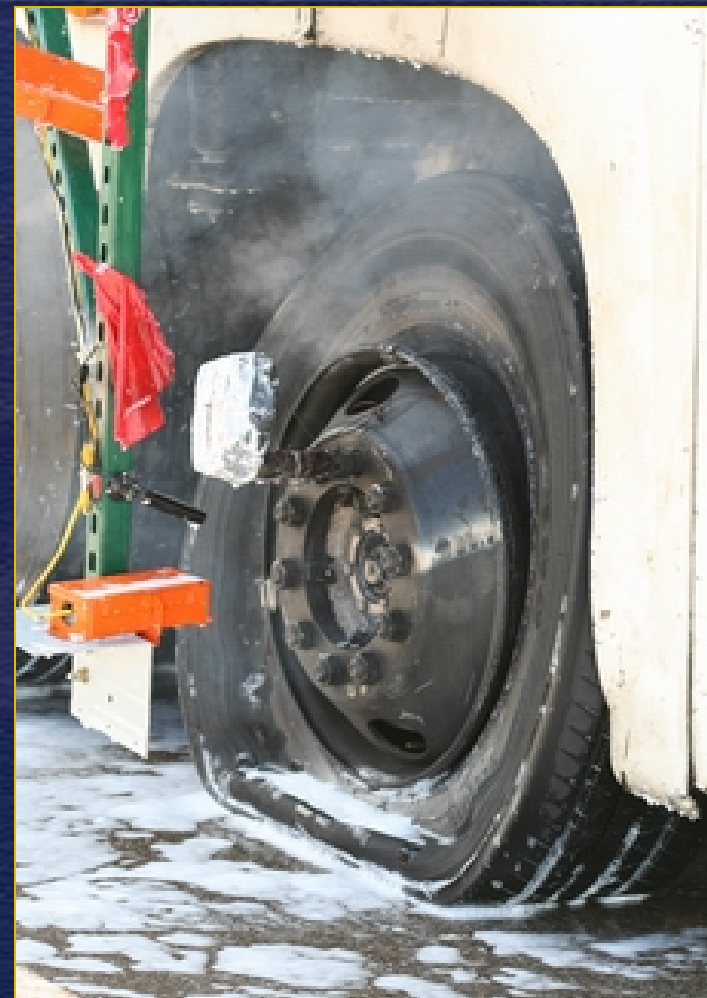
# Tire Fire Testing

Tire fires are hard to put out:

- Superheated wheel components are difficult to cool down
- Access to components is limited
- Hot hub and brake components reignite tire
